CORROSION BEHAVIOR OF METAL MATRIX COMPOSITES

R.C. Paciej and V.S. Agarwala
Air Vehicle and Crew Systems Technology Department
NAVAL AIR DEVELOPMENT CENTER
Warminster, PA 18974

FEBRUARY 1987

FINAL REPORT

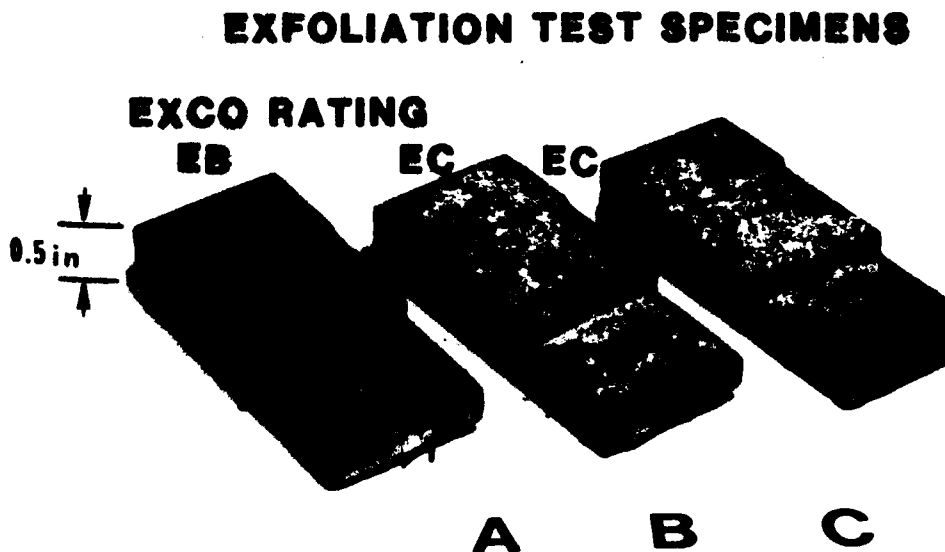
Figure 3. Exfoliation test specimens prior to removal of corrosion products.

Figure 3 shows photographs of the exfoliation test specimens. As shown, tempers A, B and C have an EB, EC and EC EXCO rating, respectively. The MA-87 material shows pitting during the EXCO test (17). In the EXCO test, more corrosion products and copper deposits were found on temper C than B, and with a lesser amount on A. The reason for the severe attack of specimens B and C may be due to presence of active phases at the SiC-matrix interface. SiC particles acting as heat sinks during water quenching would significantly affect the solubility and diffusivity of solute elements in the matrix material, such that it could form areas containing only active components. The de-alloying and subsequential plating of copper could also be responsible for the severe attack observed for tempers B and C.
